Flexural and In-Plane Shear Testing on Flexlock Concrete Masonry Panels

Cercorp Initiatives Incorporated

**NATIONAL
CONCRETE MASONRY
ASSOCIATION**

Project No. 01-391

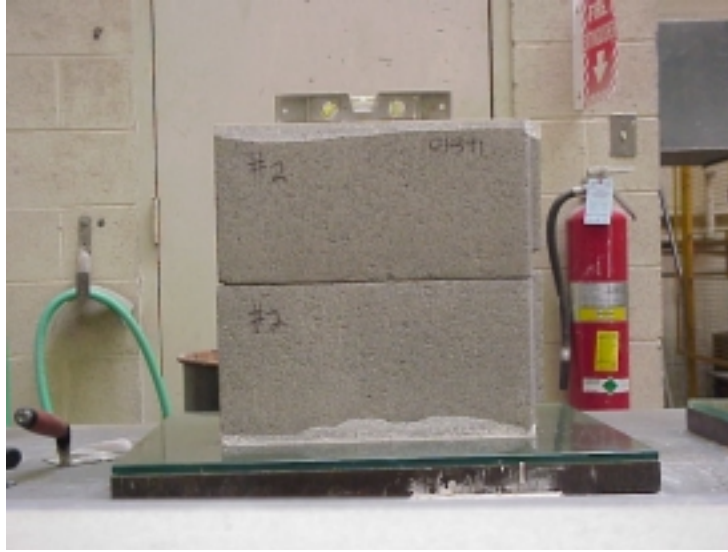
Concrete masonry prisms were constructed to determine the dry stack compressive strength. Two units were gypsum capped, according to ASTM C 140, and then placed one atop another to form a dry stack prism. This prism was then placed into the compression machine and loaded to failure. The test procedure followed ASTM C 1314 – *Test Method for Compressive Strength of Masonry Prisms*. Figure 2 shows the dry stack prism.

Figure 2—Dry stack prism

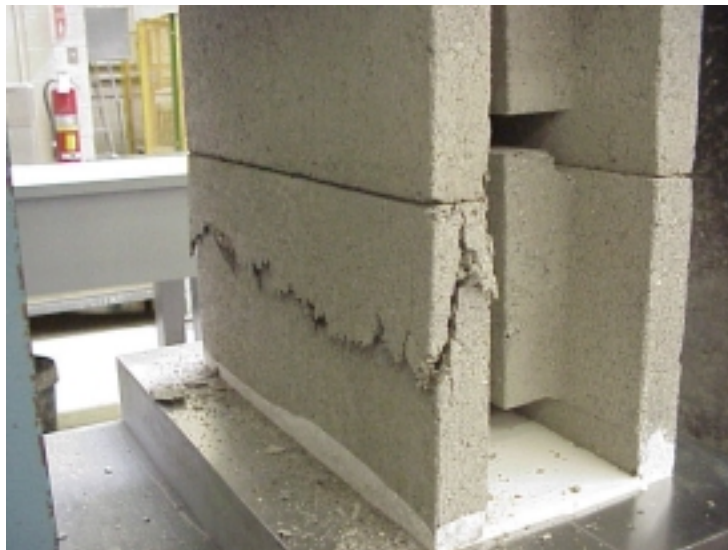
The average gross area compressive strength was tested to be 940 psi. Only the faceshells carry load, so the net area compressive strength can be determined using the average faceshell thickness determined from the ASTM C 140 testing. The average net area was determined to be 42.2 in² and the average masonry prism strength was 2,655 psi. Figure 3 shows the typical failure mode of the prism and Table 3 lists the individual prism strength tests. Figure 3 shows a uniform distribution of load across the face shell. It was noted that at approximately 30,000 lbs. a crack appeared through the webs of all the units tested and Figure 4 shows a typical crack in the web.

Figure 3—Prism failure

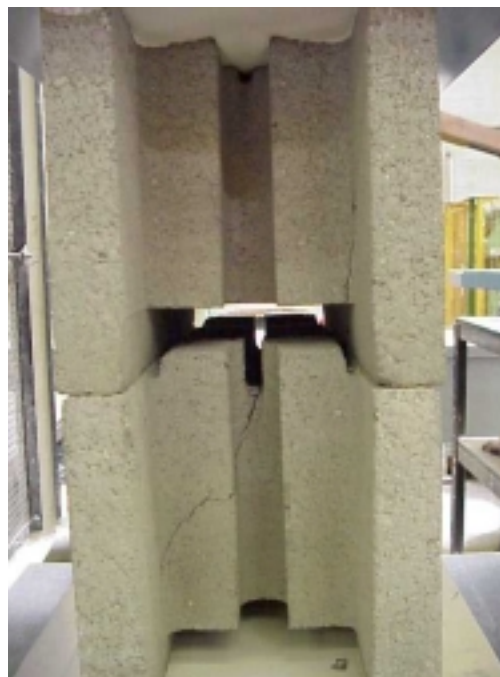
Figure 4—Web crack at 30,000 lbs, test no. 2

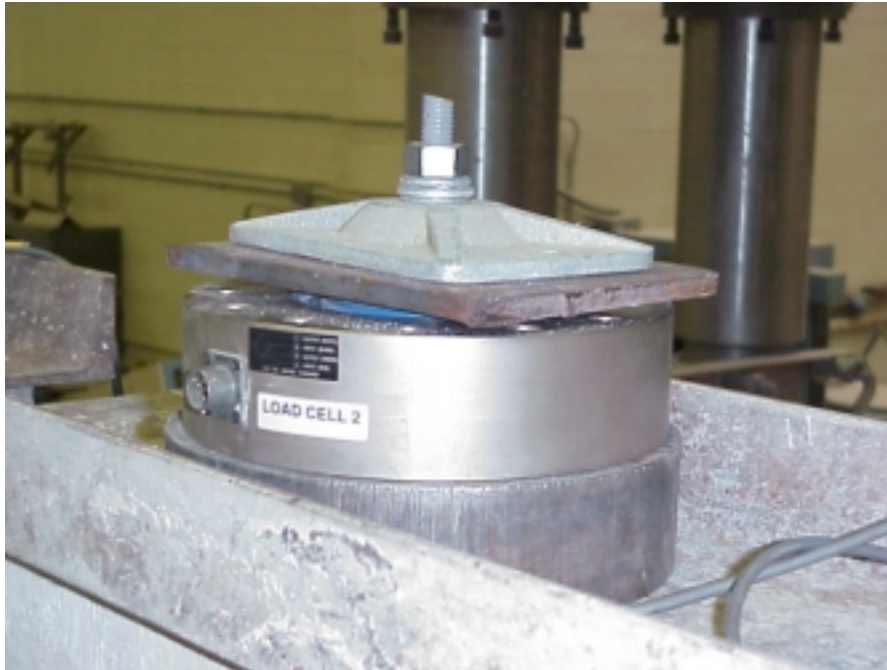
Subsequent testing was conducted to measure the tension in the tendons by using load cells. In this test two walls – 104 inches high and 56 inches wide – each with two tendons were constructed exactly as the flexure walls described above. Each tendon had a load cell placed atop the top channel and then under the tendon bearing plate as shown in Figure 6. For each

tendon, elongation was measured, tensile load was monitored using the load cell, and torque was measured. The tendons were tightened as previously done and the same observations regarding the twisting of the tendon and the nut grinding the indicator washer were noted. The tendon was tightened to a point where tendon failure would occur and the torque was measured to be 125 ft-lbs. in both walls. The load cell measurements were recorded and the average tensile load was measured as approximately 5000 lbs. The individual tendon loads were: 5296 lbs., 5160 lbs., 5333 lbs., 4029 lbs.

Figure 6—Load cell setup for tensile load measurement

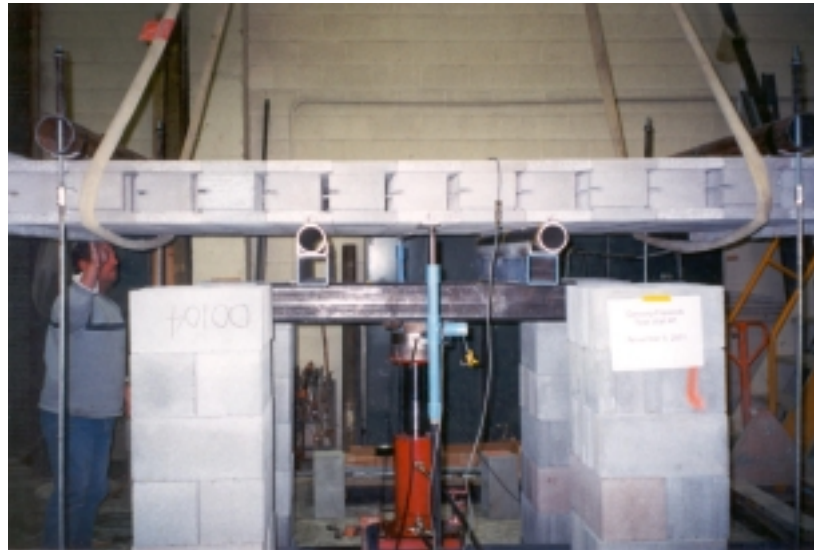
All panels were tested in accordance with ASTM E 72, *Standard Test Method of Conducting Strength Tests of Panels for Building Construction*. The test was conducted with the wall in a horizontal position using third point loading as shown in Figure 7. The load was applied using a hydraulic ram and load was measured using a precision load cell with 50,000 lb capacity and deflection was measured using two linear displacement sensors (LVDT). Additionally, joint expansion was measured at two locations using dashpots.

Figure 7—Test Setup for Third-Point Loading

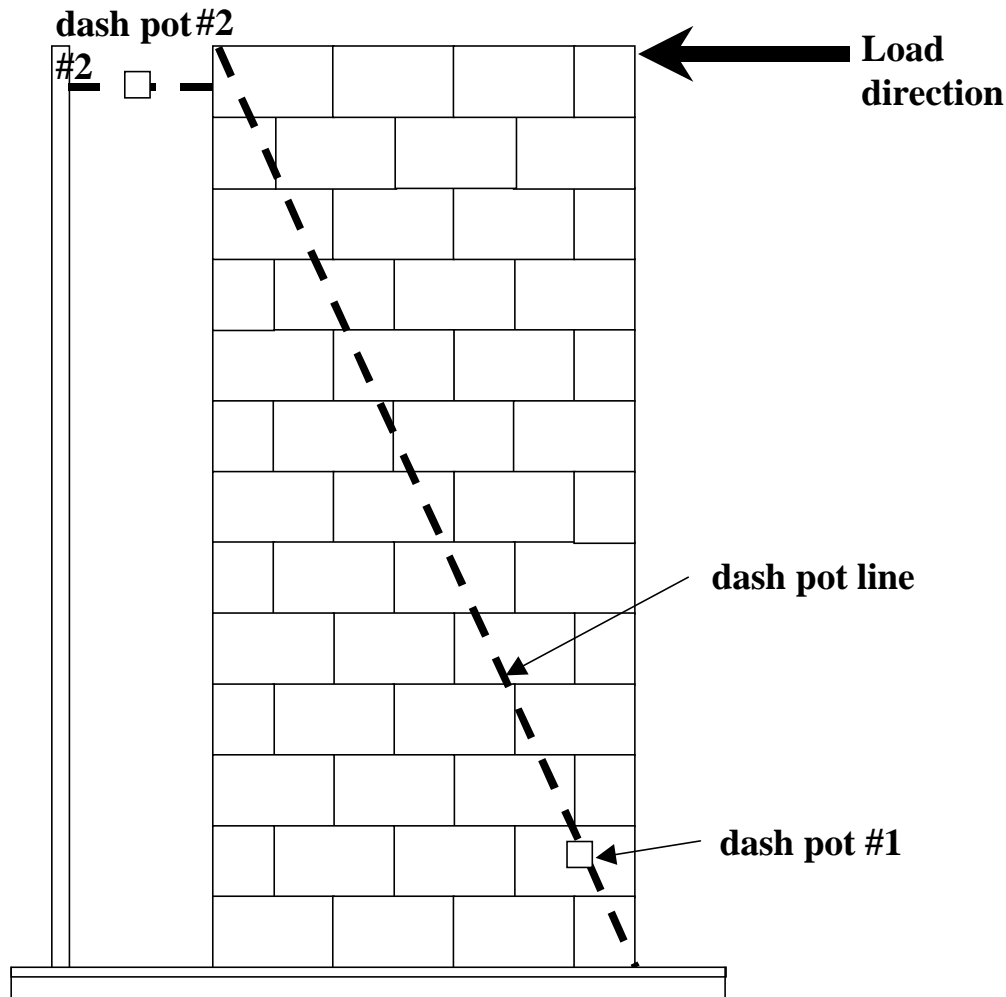
Lateral load was applied to the wall specimen by means of a hydraulic ram of 100-kip capacity. The magnitude of the applied load was measured with a 50-kip load cell that was placed between the hydraulic ram and the wall test panel. Dashpots were placed in two locations to measure the displacement and drift of the wall specimens. Figure 9 shows the placement of the dashpots to measure the displacement (dashpot #1) and drift (dashpot #2).

Figure 9—Location of Dashpot #1 and Dashpot #2

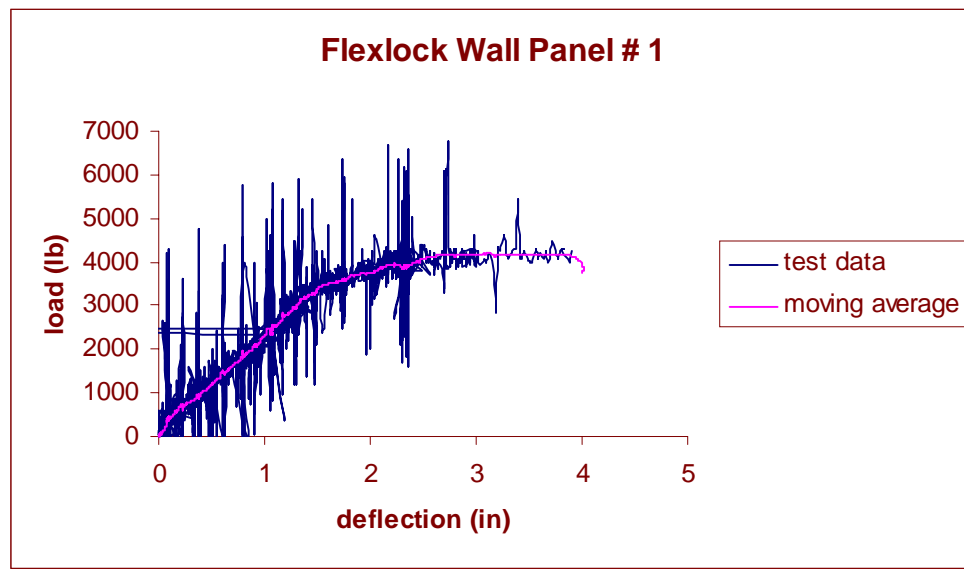
determined when the wall panel could not sustain additional load. A smoothing routine – moving average with a unit interval equal to 100 – was used on the load-deflection data to eliminate any noise in the data caused by the laboratory environment. Figure 10 shows a comparison between the raw load-deflection data and the moving average of the data. It was determined that the signal interference in the data shown in the figure was on the order of 100 Hz and could be filtered out during the data acquisition. This was done for test panels # 4, 5, & 6, although the moving average filter was applied to all the data to get smooth curves.

Figure 10—Comparison Between Test Data and Moving Average Filter

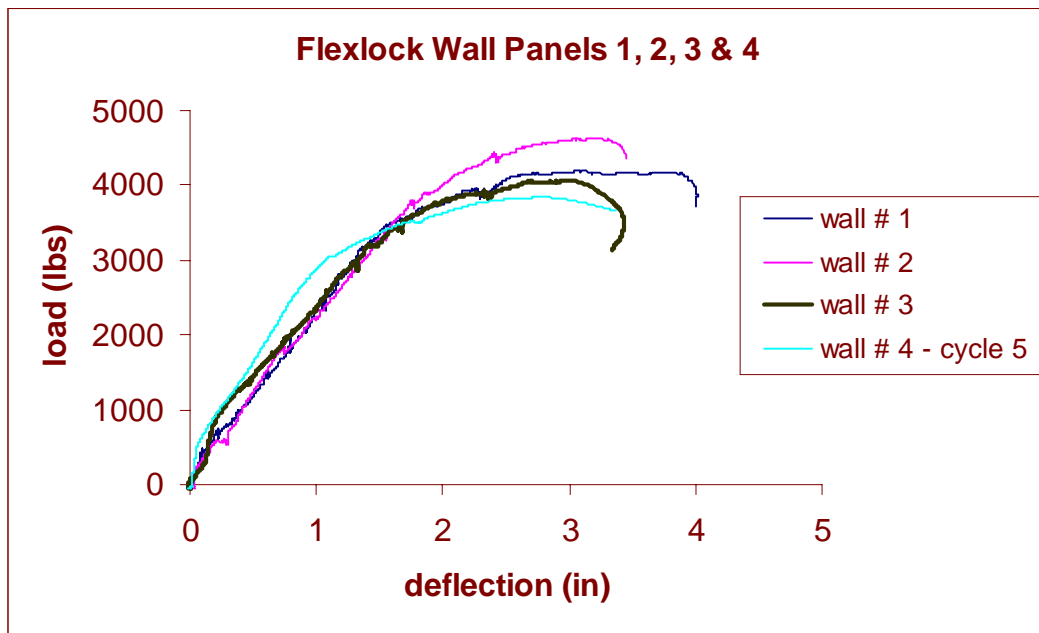
Figure 14—Comparison of Wall Panels #1, #2, #3, and #4 – Cycle 5

The next two wall panels – panels 4 & 5 - were cycle tested to see if this loading affected the performance of the wall panels. Wall panel # 4 was loaded at 500 lb increments to 2500 lbs and then relaxed and reloaded four times. On the fifth cycle, the wall panel was loaded to failure. Figure 13 shows the results of this cycle test, which shows no degradation of wall capacity over the five cycles. The results for wall # 4 - cycle 5 - were compared to the first three walls and are shown in Figure 14. Finally, Figure 15 shows the cycle testing for wall # 5, showing the 4 cycles of loading to 2500 lb.

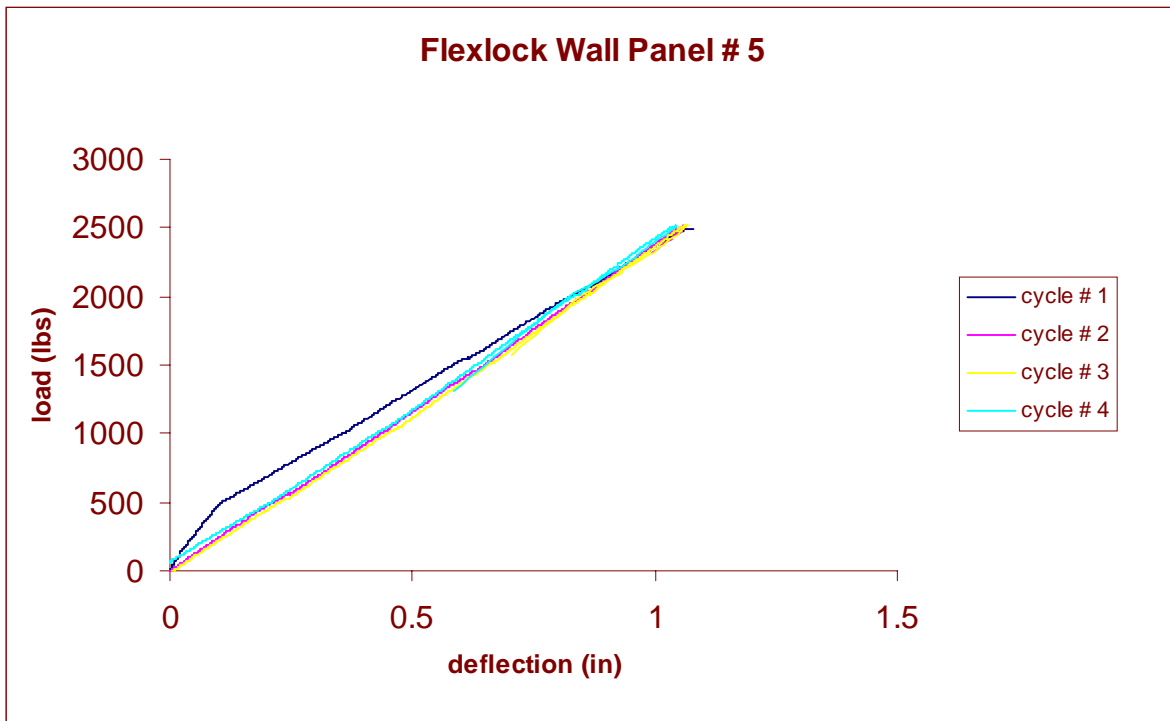
Figure 15—Comparison of Wall Panel #5 Cycle

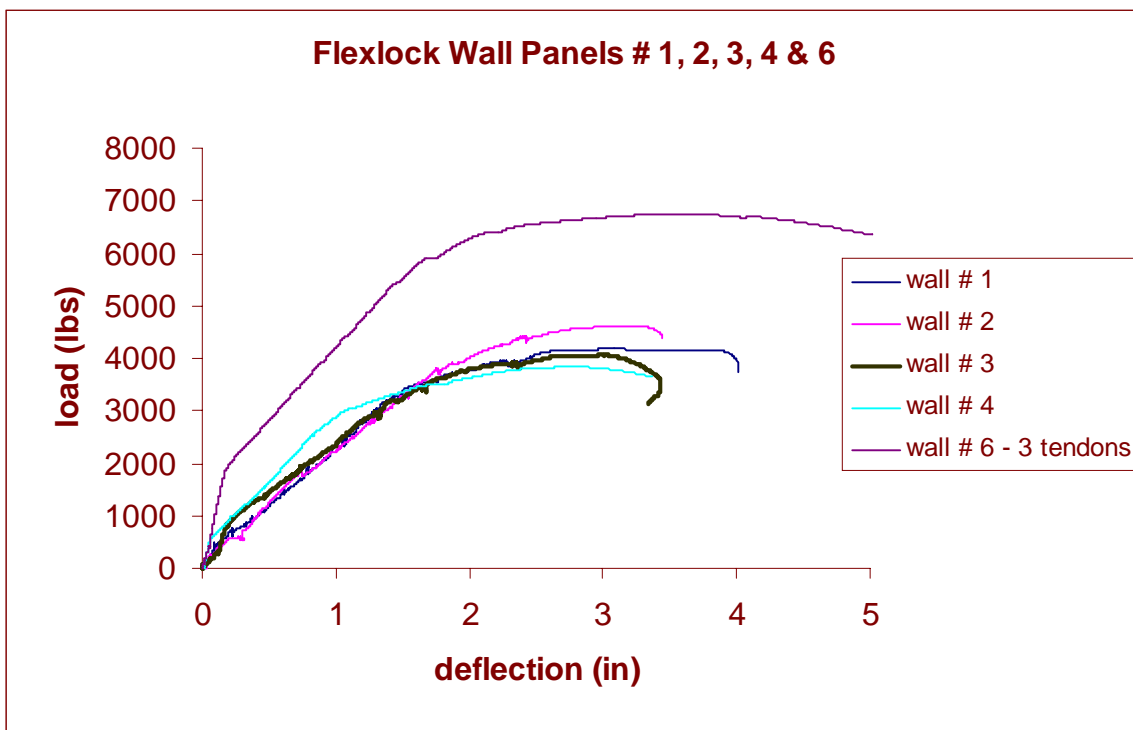
Figure 16—Flexlock Wall Panel #6 Compared to Wall Panels 1, 2, 3, and 4

Wall panel # 6 was assembled with three tendons spaced 16 inches apart and tested to failure by loading the wall panel at 500 lb increments. Figure 16 shows the load-deflection curve for this test along with the tests for the first four panels.

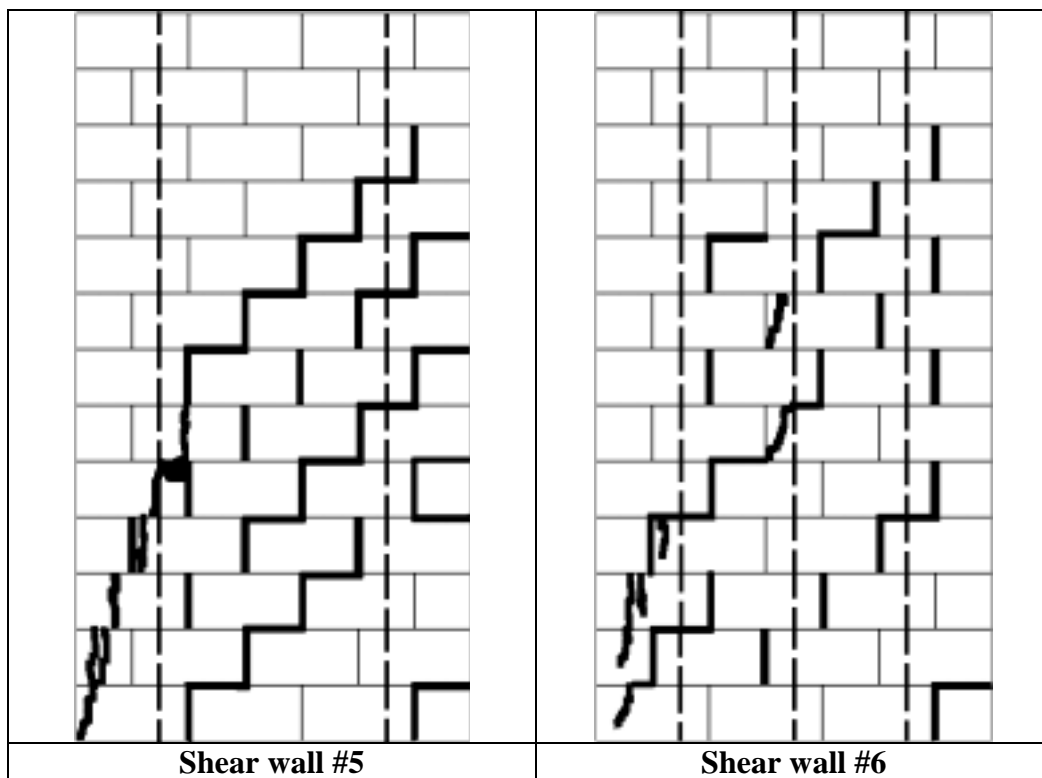
As the walls were subject to lateral force, rotation about the corner of the wall panel was observed and this drift was measured as the lateral movement resulting from this rotation. In effect, these wall panels all behaved as cantilevers with shear slip. As more lateral load was applied, the crack pattern was observed and photographed. These photos were used to sketch the crack patterns that are shown in Figures 17, 18, and 19. In the figures, tendons are shown as dotted vertical lines. Finally, Figures 20, 21, and 22 are the load-drift curves for the 104 inch, 72 inch, and 56 inch wall panel, respectively.

Figure 19—Crack Pattern – 56-inch Wide Panels

Crushing of the toe of the wall was observed in 5 out of the 6 wall panels tested and the shorter panels generally exhibited more extensive toe crushing. For the longest wall panels – 104 inches – adding a third tendon introduced more extensive block crushing. For the shorter wall panels, adding a third tendon introduced more extensive block crushing and more random cracking not associated with typical stair-step cracking associated with shear failures. Table 6 summarizes the cracking observed in the shear wall test panels and estimates the area of toe crushing. The toe crushing area was estimated by taking the height of the unit and multiplying by the faceshell thickness. In all the shear wall panels, the units were cracked through the wall, so the toe crushing area was estimated using both faceshells.

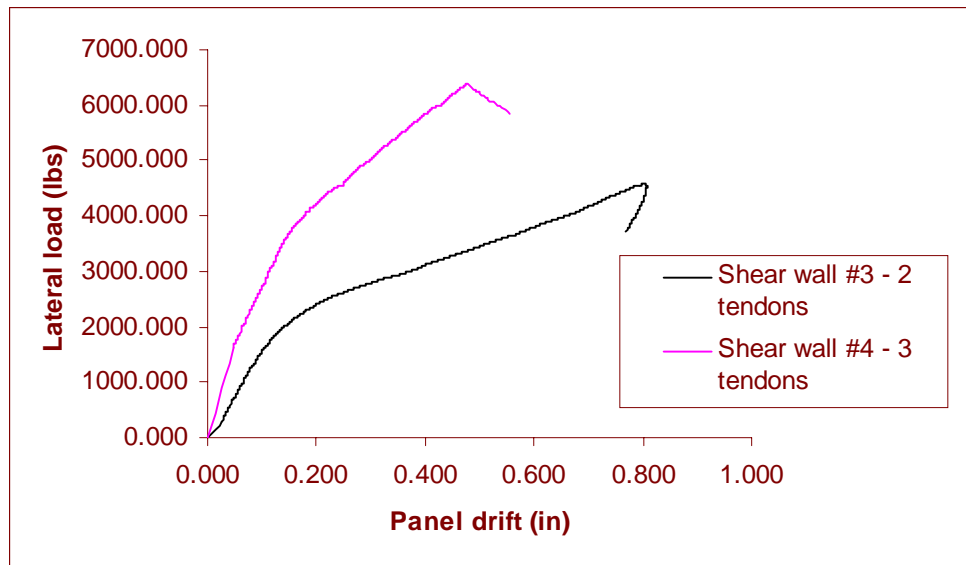
Figure 21—Comparison Between Wall Panels #3 – 2 Tendons and #4 – 3 Tendons

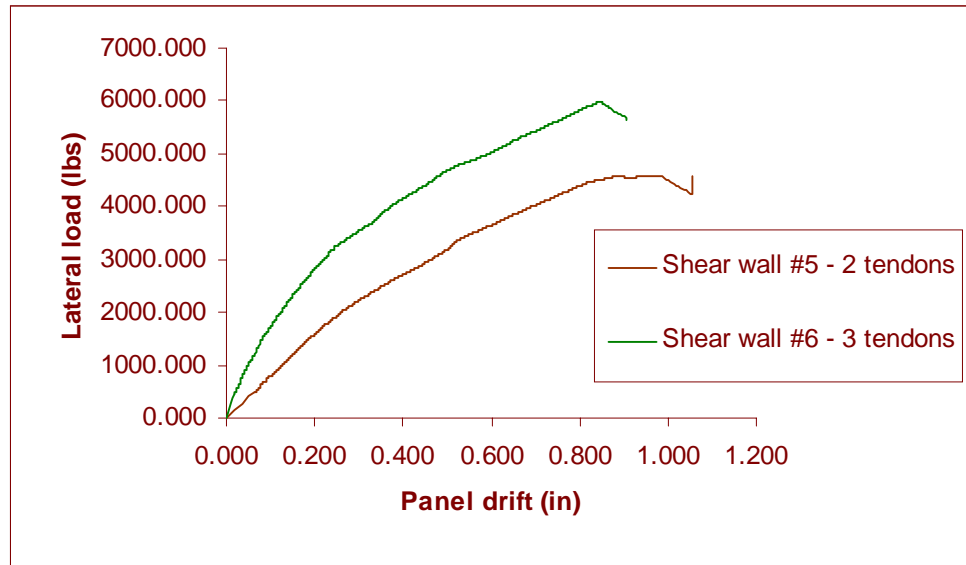
Figure 22—Comparison Between Wall Panels #5 – 2 Tendons and #6 – 3 Tendons
