In-Plane Shear Testing of Flexlock Concrete Masonry Walls

Cercorp Initiatives Incorporated

Project No.: 02-407
Date: July 2003

In Plane Shear Tests of Flexlock Concrete Masonry Walls

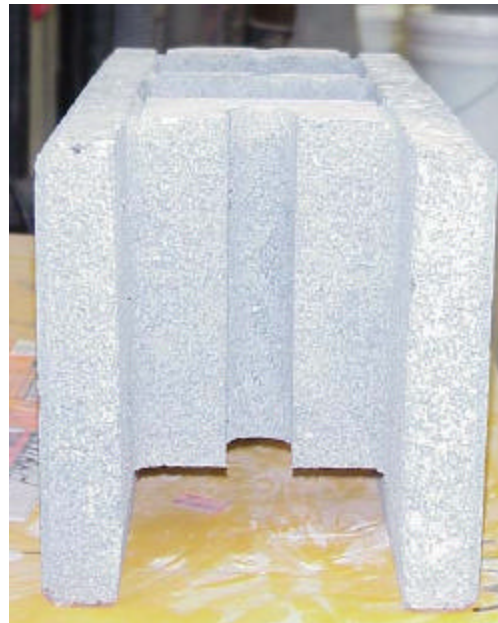
**Figure 2—Flexlock CMU Showing
Compression Testing Orientation**

Flexlock concrete masonry units have webs that extend above the face shell when the block is orientated in the as-laid position. The webs were saw cut to the elevation of the faceshells in order to conduct a full-unit compression test. The webs, with the units in the as-laid position, are recessed from the bottom faceshells. The face shells were left intact, and Figure 2 shows the unit, as tested. Therefore, net area for the determination of compressive strength used the thickness of the face shells and not any web area. Each unit was gypsum-capped prior to testing in compression.

Six full units, modified as described above, were tested in accordance with ASTM C 140, *Standard Methods of Sampling and Testing Concrete Masonry Units* and the results are shown in Table 2. Average, standard deviation, and coefficient of variation were calculated and are also shown in the table. For these tests, the coefficient of variation was calculated to equal 8.7 percent and the range of the data was 1014 psi. The data spread appears to be moderately high. Testing procedures were reviewed and showed no deviation from established practices.

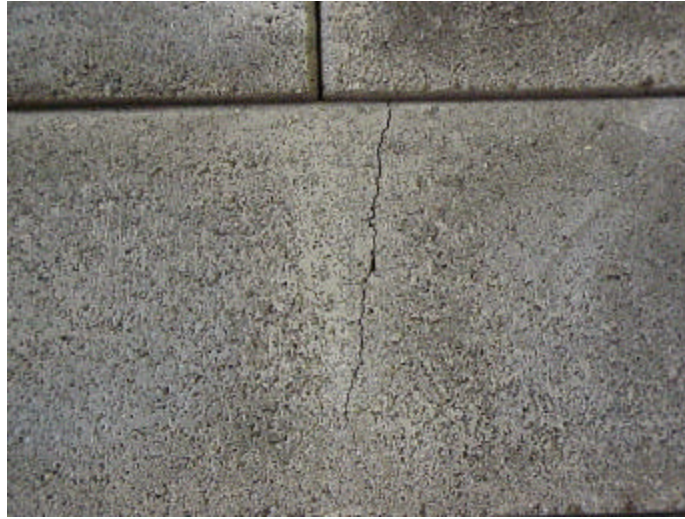
Figure 4—Hairline Crack in CMU

During the tensioning of the 56-inch wide wall specimens, cracking occurred within the CMUs. The cracks were observed to be small hairline cracks and an example of one of the cracks is shown in Figure 4. Figure 5 shows the location of the cracking in the 56-inch wide wall specimens. Cracking was not observed during the tensioning of the 72-inch wide wall specimens. A few CMU specimens were observed to have high spots, but a detailed measurement of each block height was not conducted. The 56-inch wide wall specimens were tested in this condition.
